# Designing the school physical plant and facilities: An instructional material for Technical Drafting 10

**Abstract:** The purpose of this study was to evaluate the physical plant status of the DepEd Toledo City Division in 2018 in order to suggest a development strategy. With the use of various statistical approaches, the researcher adopted a descriptive nominative approach. This is done to ascertain the conditions, practices, and scenarios that are typical of the research setting to find out what the superintendent of the Schools Division, the chiefs of the Curriculum Implementation Division, the School Governance and Operations Division, the Division Engineer, the Division Risk Reduction Management Project Development Officer, the section heads, the office staff, the school heads, and the teachers think about the various parts of the division's physical infrastructure. The first section, Plan A, contains the proposed five-year development plan for the physical plant and facilities of the DepEd Toledo City Division. This plan includes recommendations for improving the physical plant of the school and its facilities in order to accommodate the division's growing staff and to add

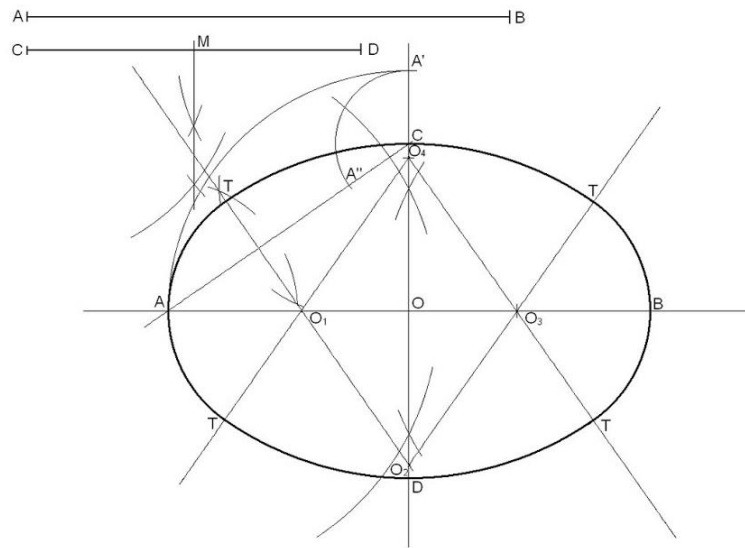
Figure 2

Looking at the drawing, it comprises circles and other geometrical figures that were used by the draftsman to form a layout for an ideal workplace. For the ellipses, here's how it is made.

References: A-B, C-D

1. Draw 4 inclined lines following the references.
2. Using a compass draw an arc pointing the needle to intersection D while striking an arc with the pencil from T to T.
3. Using a compass draw an arc pointing the needle to intersection C while striking an arc with the pencil from T to T at the bottom part of the drawing.
4. From intersection O1, draw an arc connecting T to T on the left side. From intersection O2, draw an arc connecting T to T on the right side.

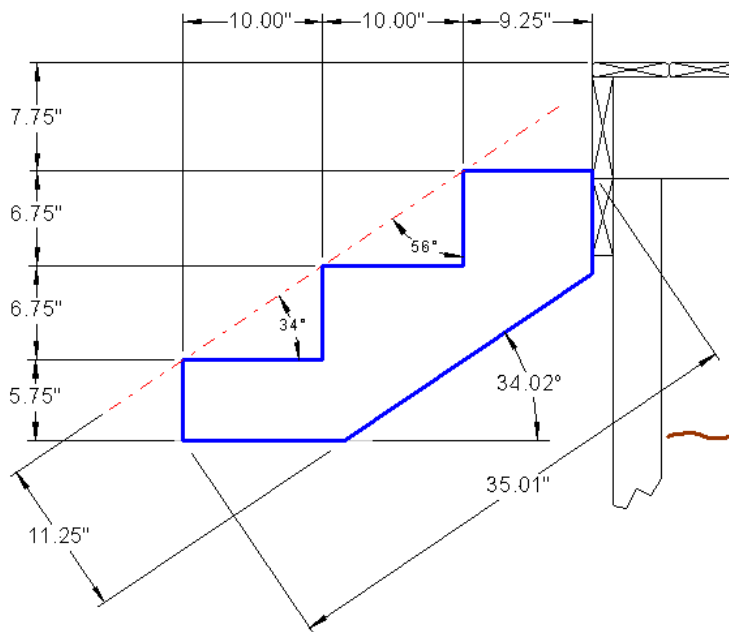
Layout Cuts On 2x12 Material

Figure 5 shows the standard and safe dimensions of a staircase as figured out by [hammerzone.com](http://hammerzone.com). Stairways and fire exits should be adequate and standard in size and number and conveniently located.

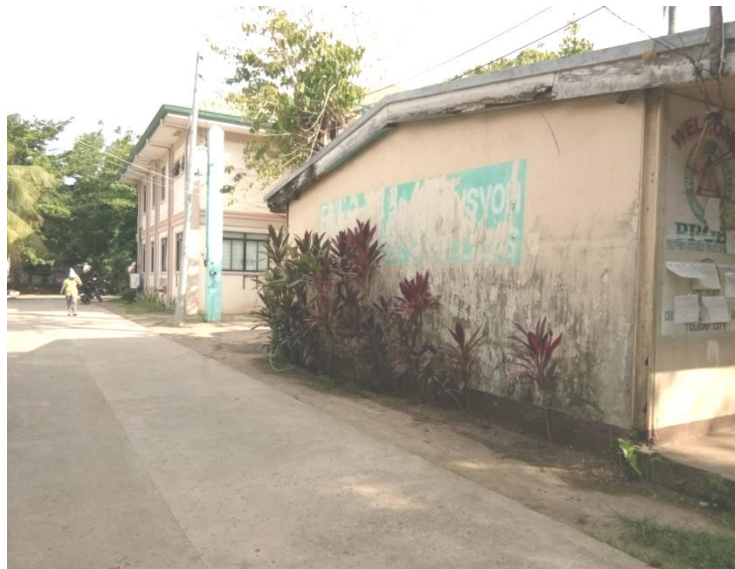
Figure 15. Existing

The Table shows that the highest weighted mean for site development is item 1.1 - Site Provisions for growing employee population and future expansion. This means that respondents found out that this item is very useful. On the other hand, the lowest is item 1.6 - Area of outdoor educational activities(Social, physical, athletic,

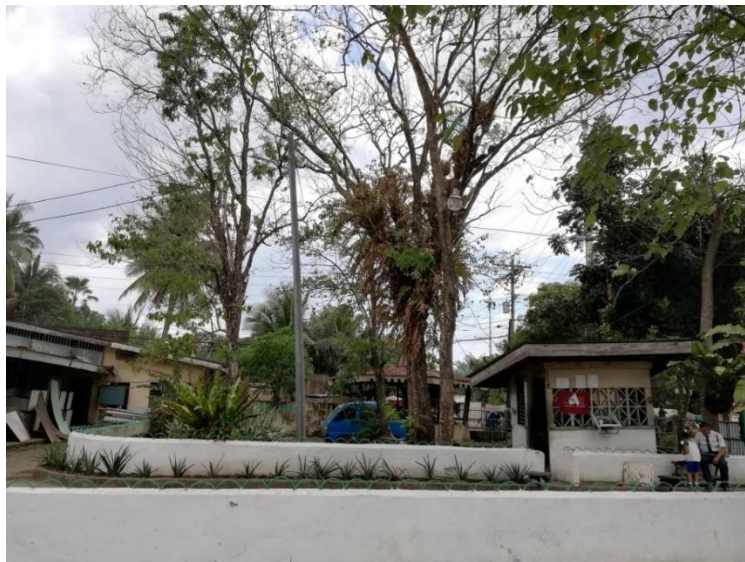
Figure 17. Existing

The physical plant of DepEd Toledo City Division as to its site landscaping was rated as useful, which means the availability of landscape, useful as average according to availability of landscape, and not useful for not observed in the landscape.

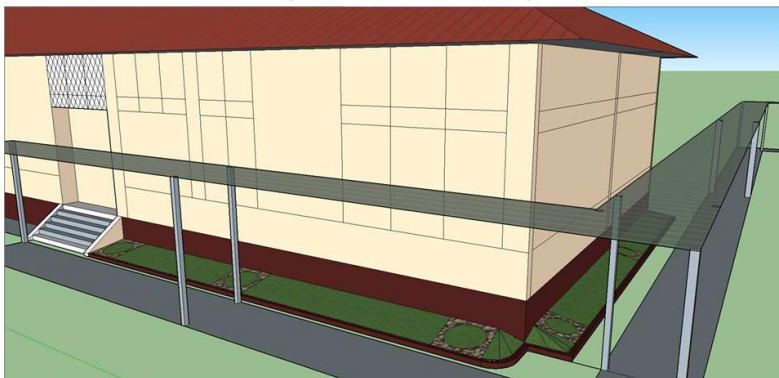
Figure 22. Development Plan

In the overall, the facilities layout and location of DepEd Toledo City Division was rated good and identified as useful according to its weighted mean. The findings imply that covered walks for easy access between buildings and to provide walkways/footpaths for access between buildings and areas area needed.
